# Manhole Inspection Summary

Manhole # S27C1\_017MH

Insp Date: **4/15/08 11:03 AM**

**Location** Address: **BEHIND 2312 CEDLEY ST.**

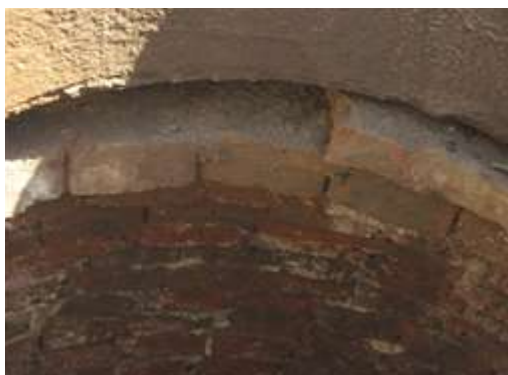
Defect 1

Condition: ☐ Sound ☐ Cracked ☐ Root Intrusion ☒ **Loose Brick** ☒ **Deteriorated**

Infiltration: ☐ None ☐ Joint ☐ Cracks ☒ **Mortar** ☐ Roots ☐ Wall

MISSING MORTAR AND BRICK WITH EVIDENCE OF CHIMNEY INFILTRATION

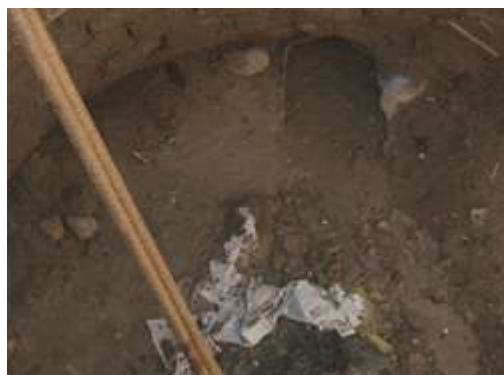
Defect 3

Condition: ☐ Sound ☐ Cracked ☐ Root Intrusion ☐ Deteriorated ☐ Leaks ☒ **Debris**

DEBRIS IN CHANNEL AND ON THE BENCH

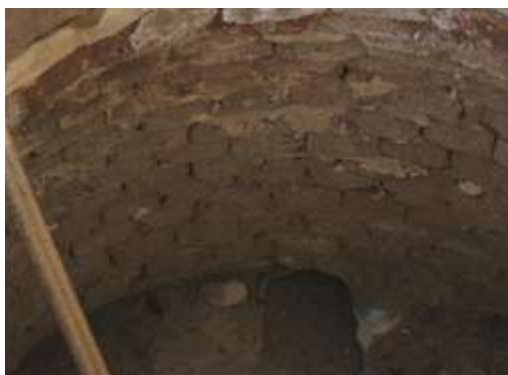
Defect 2

Infiltration: ☐ None ☐ Joint ☐ Cracks ☒ **Mortar** ☐ Roots ☐ Wall

MISSING MORTAR AT CORBEL AND BARREL WITH EVIDENCE OF INFILTRATION

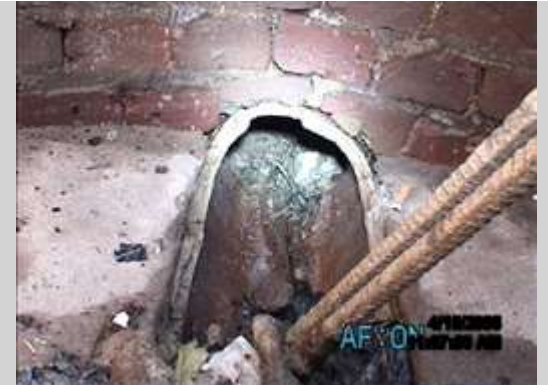
12 O'Clock Outflow

6 in. Circular Gravity Sewer  
Pipe Out @ 12 O'Clock

Deposits: ☐ None ☒ **Mud** ☐ **Gravy** ☐ Debris ☐ Grease

Silt Depth: 12 (in.) Deposits Extent: **Heavy**

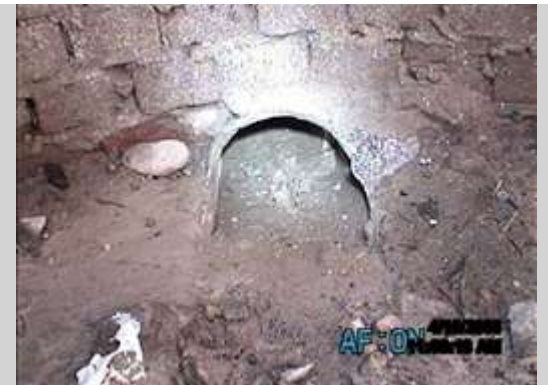
6 O'Clock Inflow

6 in. Circular Gravity Sewer  
Pipe In @ 6 O'Clock

Deposits: ☐ None ☐ Mud ☒ **Gravy** ☐ Debris ☐ Grease

Silt Depth: 12 (in.) Deposits Extent: **Heavy**
